## **Bolton Council Flooding Investigation Report**

### **Flooding at Horwich and Lostock on 16<sup>th</sup> May 2021**

#### **Bolton Council Flood Risk Management Office**

**Version Date: 10/11/2021**

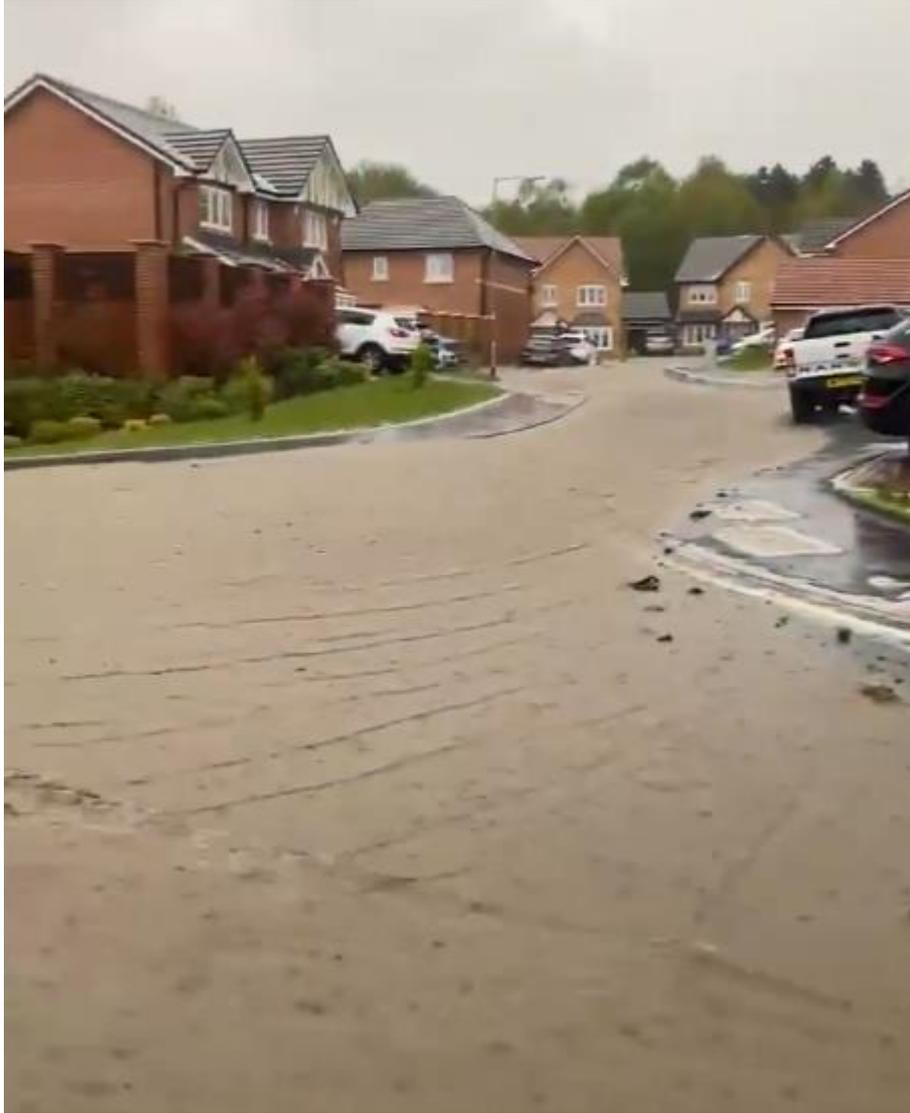
College Drive - Overland flow

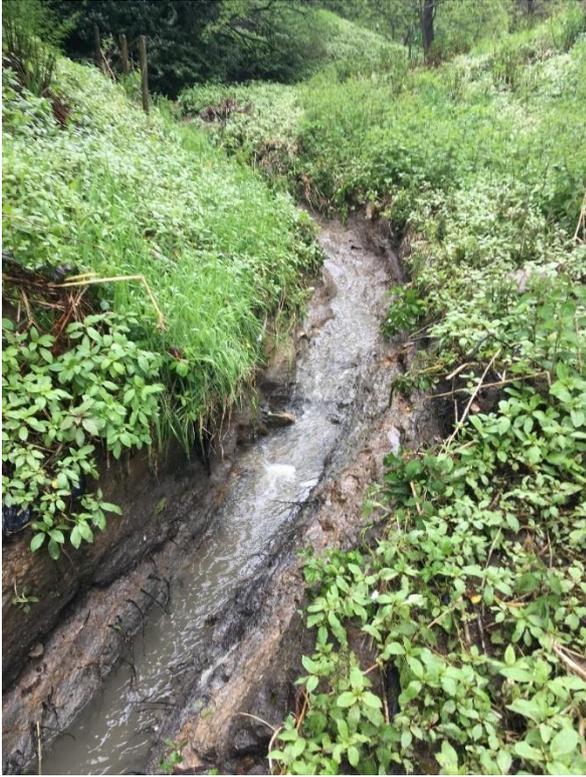
An inspection of the watercourse upstream of College Drive in the days following the storm showed that the stream bed of the watercourse had been visibly eroded over a length of approximately 340 metres. The stream bed had been scoured down to clean rock and earth, the previous stream bed which would have comprised rocks, stones and earth will have been washed downstream by fast flowing water (Photographs showing the stream bed after the storm are included in appendix 4). In addition, several small landslides to the stream embankments along the valley were observed, these would have occurred during the event and released additional earthen material to be washed downstream.

Nellis Clough – Scouring of stream bed

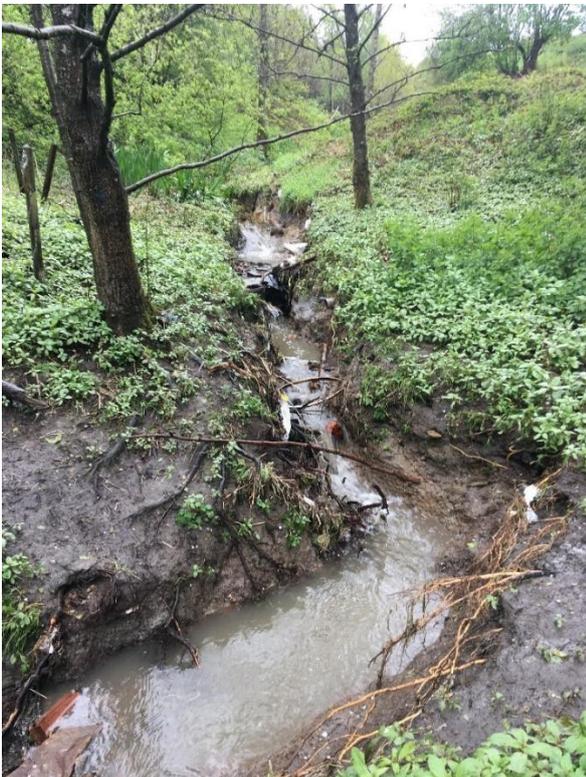
Nellies Clough – scour of stream bed and erosion

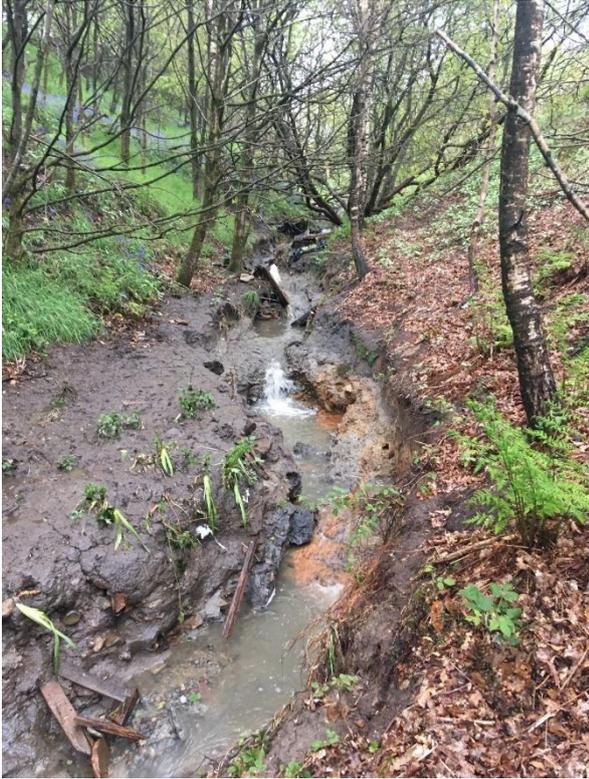
Nellies Clough – Scour to stream bed

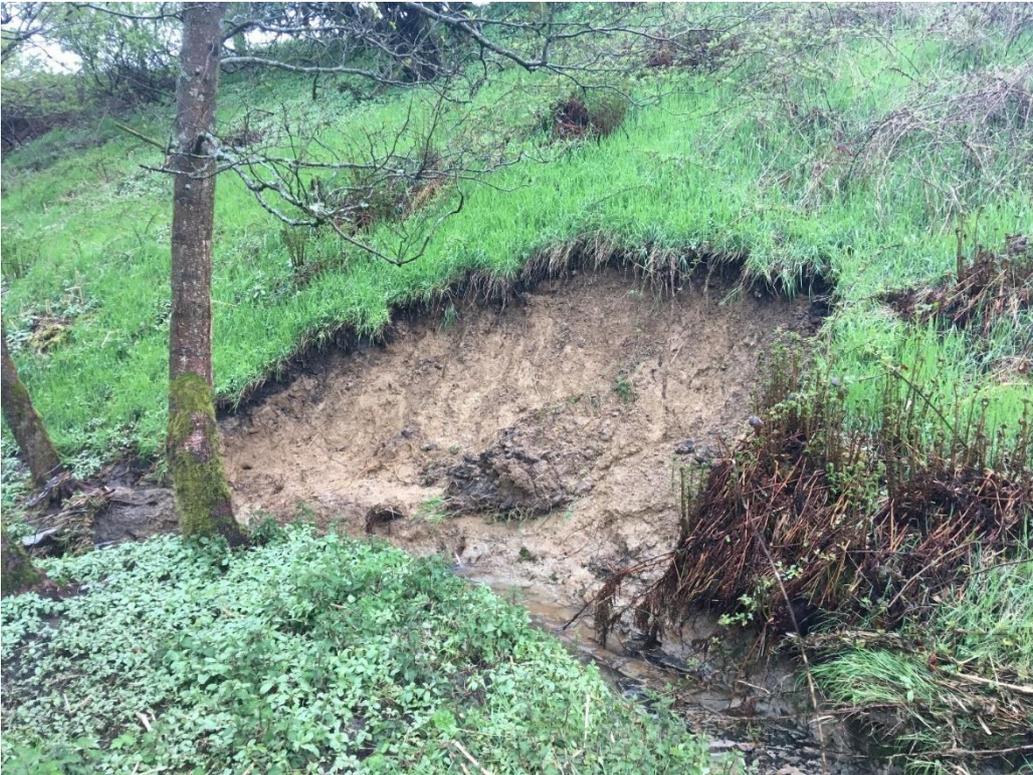
Nellies Clough – Landslip and erosion

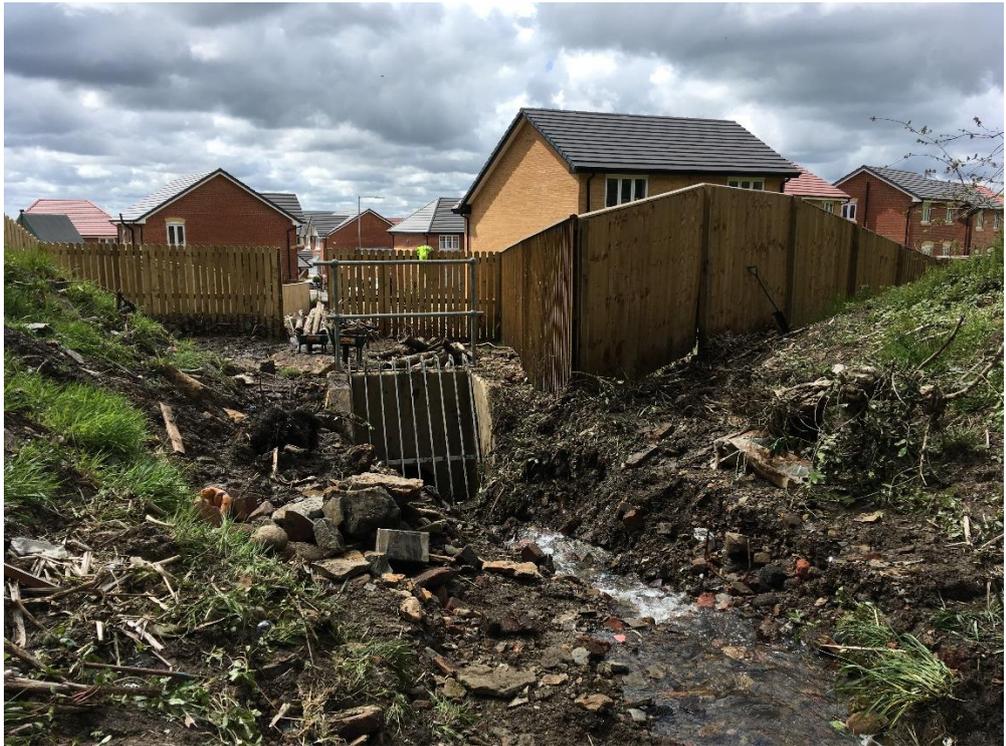
The debris load flowing downstream will have quickly blinded the debris screen on the inlet to the culvert at College Drive resulting in the overland flow that was witnessed. It was this overland flow that caused flooding to properties on the eastern side of College Drive, to St Mary's RC Primary School, and Dale Street West. The following day significant quantities of material were dug out from in front of the debris screen and disposed of.

Nellies Clough Culvert inlet and debris screen (photo taken 17<sup>th</sup> May after partial clean)

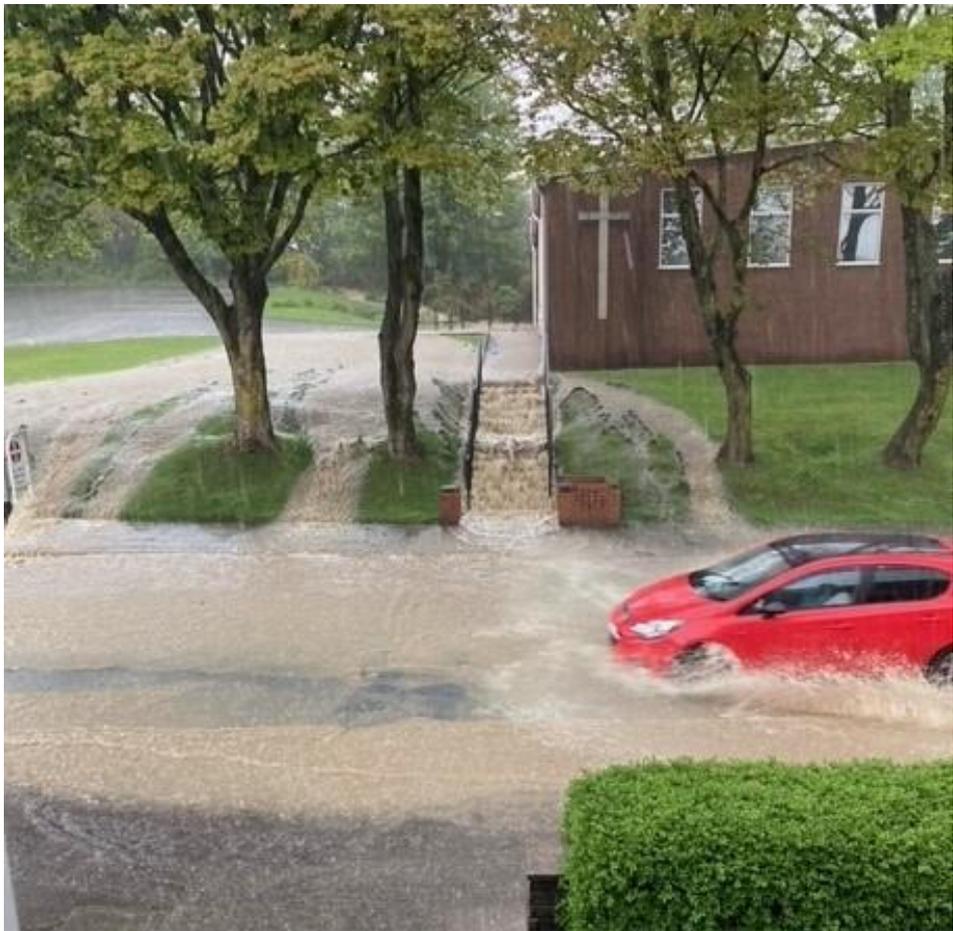
The culvert inlet at the rear of St Johns Church on Horwich Golf Course was overwhelmed by water and debris. The debris in the form of soil and silt led to the blinding of the culvert inlet resulting in increased overland flow. An inspection of the culvert inlet after the event showed that the condition and design of the inlet is poor.

Victoria Road – at St Johns Church

The LLFA has met with the Golf Club and the site landowners who have agreed to undertake work to improve the condition of inlet structure.

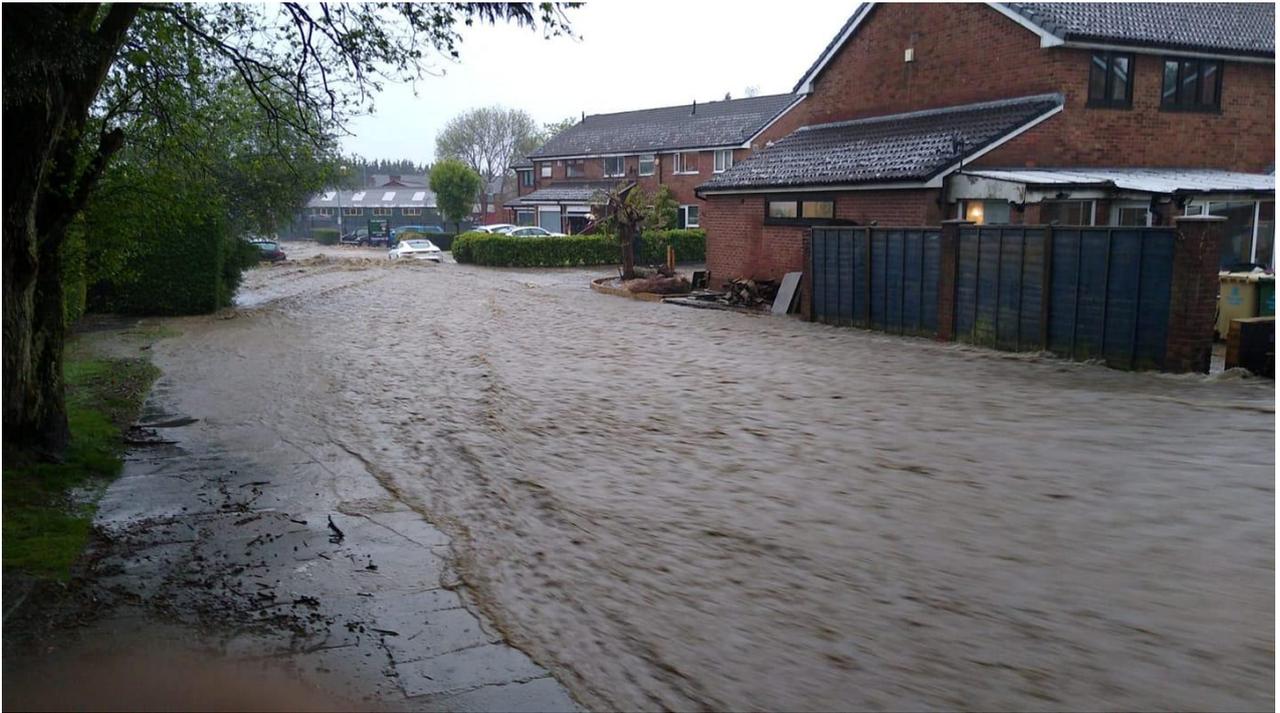
Austins Lane (downstream of Moor Platt Clough)

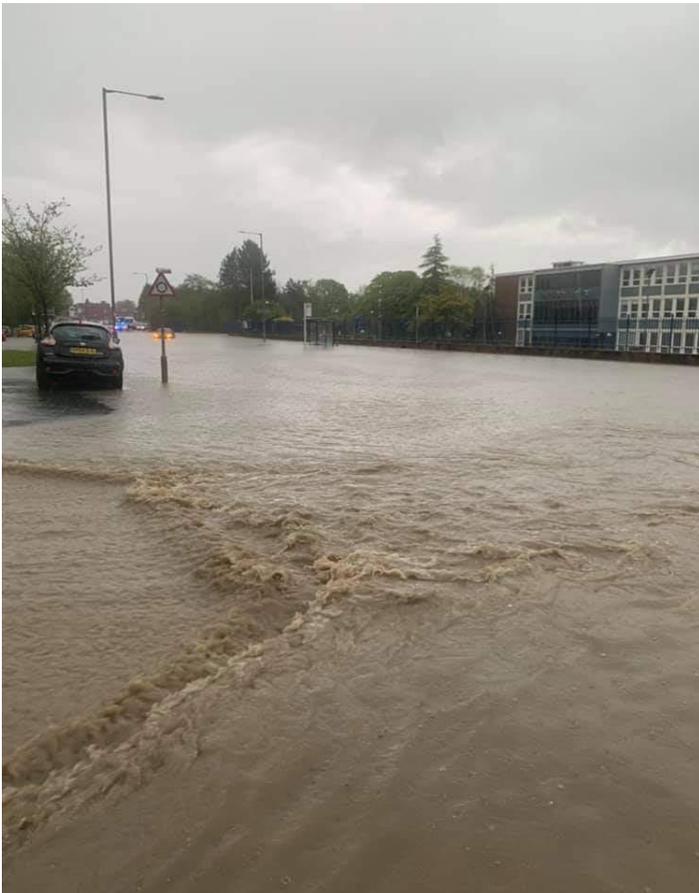
Chorley New Road at Junction of Claypool Road
