## **Bolton Council Flooding Investigation Report**

### **Flooding at Horwich and Lostock on 16<sup>th</sup> May 2021**

#### **Bolton Council Flood Risk Management Office**

**Version Date: 10/11/2021**

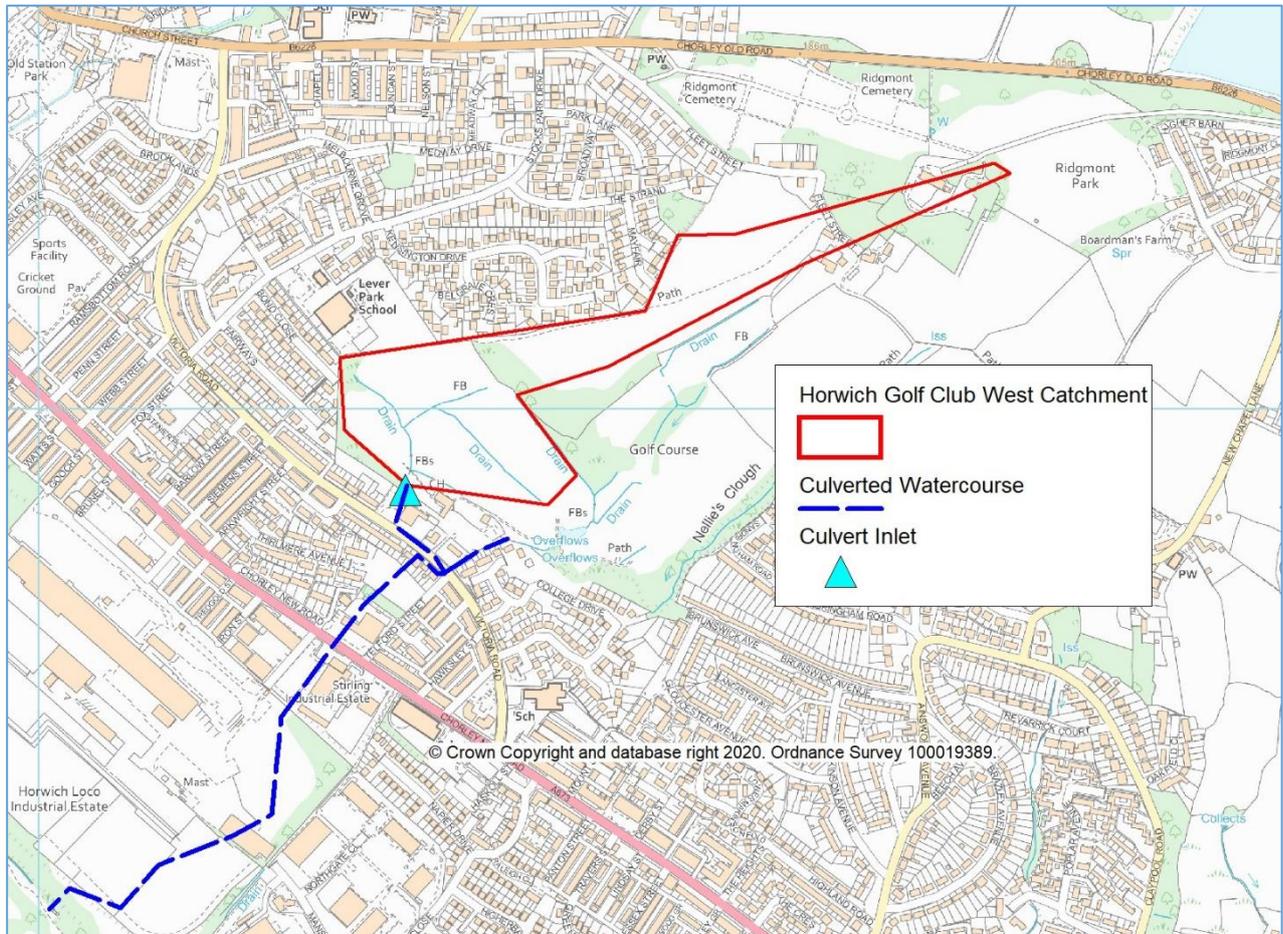
Figure 9: Map of the location of the Horwich Golf Course western catchment, culvert inlet and route of the downstream culvert.

This catchment drains to a privately owned culvert inlet at the rear of St John's Church on Victoria Road. It is then carried in a culvert in a south-west direction passing under private property, then under Chorley New Drive, and the Horwich Loco Works site before connecting to the Nellies Clough watercourse within the Loco Works site.

It is estimated that the rate of run off of water for this catchment during a 1 in 30 year storm is 192 l/s and for a 1 in 100 year storm 235 l/s.

The culvert inlet at the rear of St Johns Church on Horwich Golf Course was overwhelmed by water and debris. The debris in the form of soil and silt led to the blinding of the culvert inlet resulting in increased overland flow. An inspection of the culvert inlet after the event showed that the condition and design of the inlet is poor.

The LLFA has met with the Golf Club and the site landowners who have agreed to undertake work to improve the condition of inlet structure.

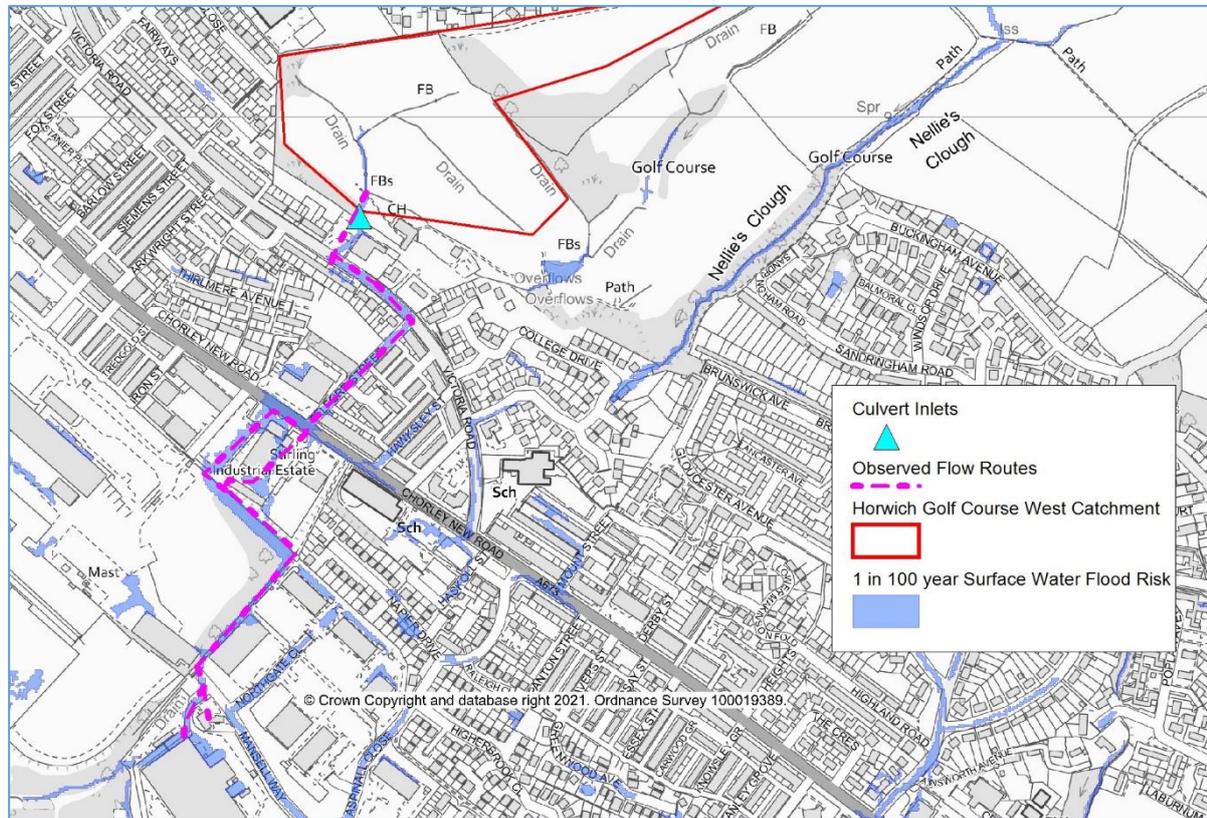
Figure 10: Map of the Horwich Golf Course western catchment, the predicted surface water flood extent for a 1 in 100 year event and the observed overland flow route.

During the event significant flows were observed issuing from the Golf Course site on to Victoria Road through the St Johns Church site, it is clear the capacity of the culvert had been overwhelmed. This resulted in overland flow down Telford Street causing significant highway damage. This flow then pooled on the much flatter land at Chorley New Road.

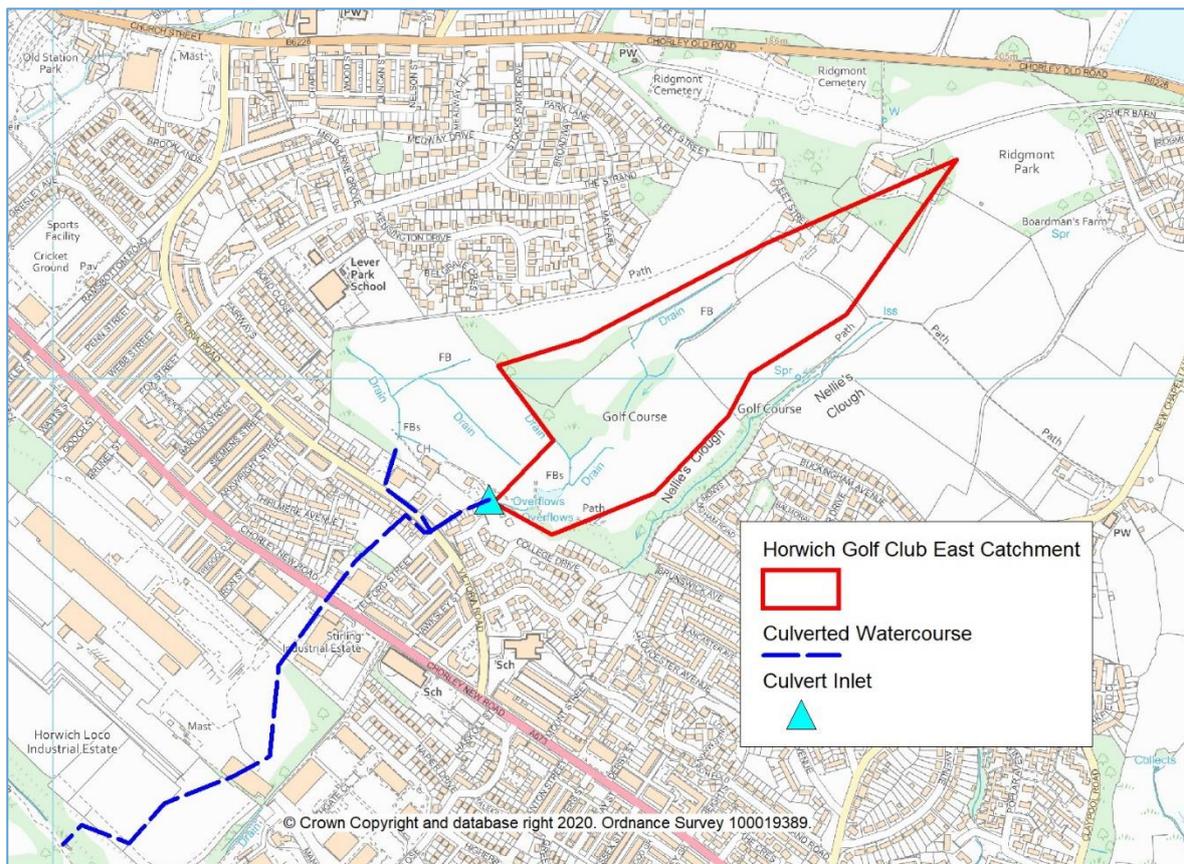
Figure 11: Map of the location of the Horwich Golf Course eastern catchment, culvert inlet and route of the downstream culvert.

This catchment drains to a privately owned culvert inlet at the rear of Middlewich Close. It is then carried in a culvert in a south-west direction passing under private property, merges with the flow from the Horwich Golf Course western catchment, then under Chorley New Road, and the Horwich Loco Works site before connecting to the Nellies Clough watercourse within the Loco Works site.

It is estimated that the rate of run off of water for this catchment during a 1 in 30 year storm is 248 l/s and for a 1 in 100 year storm 304 l/s.

The consequence of replacing the open channel with an enclosed pipe meant that there was no means of interception overland flow from the Golf Course and directing this into the downstream culvert. This resulted in overland flow from the higher golf course land into the Rivington Grange Estate at Middlewich Close. This caused extensive external flooding to gardens and some internal flooding to newly built property. The flow of water continued overland running along Victoria Road, Abernethy Street and on to Chorley New Road.

The developer has now made changes to the watercourse; removing the piped section and replaced with an open channel, so the risk of overland flow causing flood has been reduced.

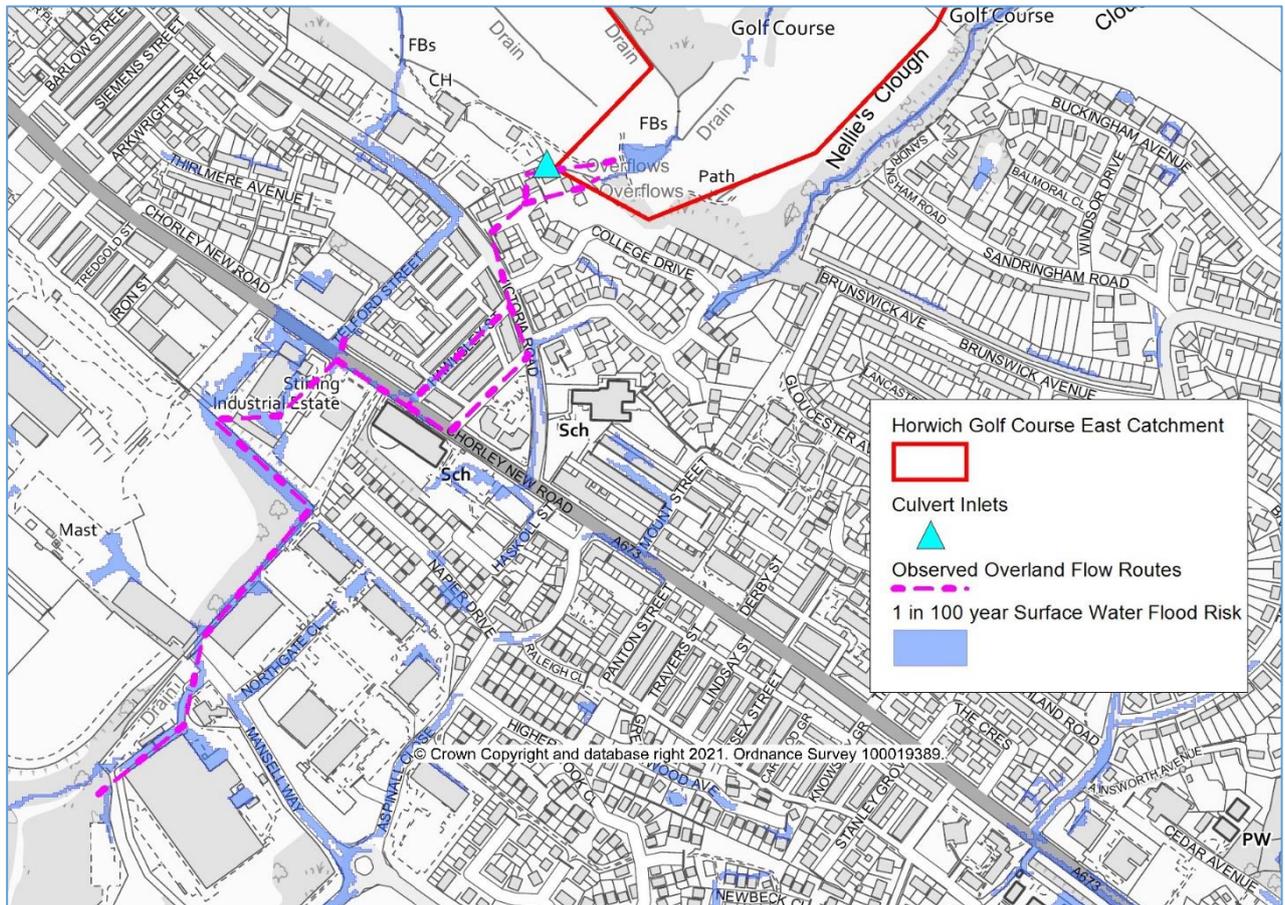
Figure 12: Map of the Horwich Golf Course eastern catchment, the predicted surface water flood extent for a 1 in 100 year event and the observed overland flow route.

During the rainfall event significant water flows were observed issuing from the Golf Course site on to the rear of properties on Middlewich Close through the College Drive development site, and onto Victoria Road. This resulted in overland flow down Abernethy Street causing highway damage. This flow then pooled on the much flatter land at Chorley New Road where it merged with other flows resulting in property flooding.

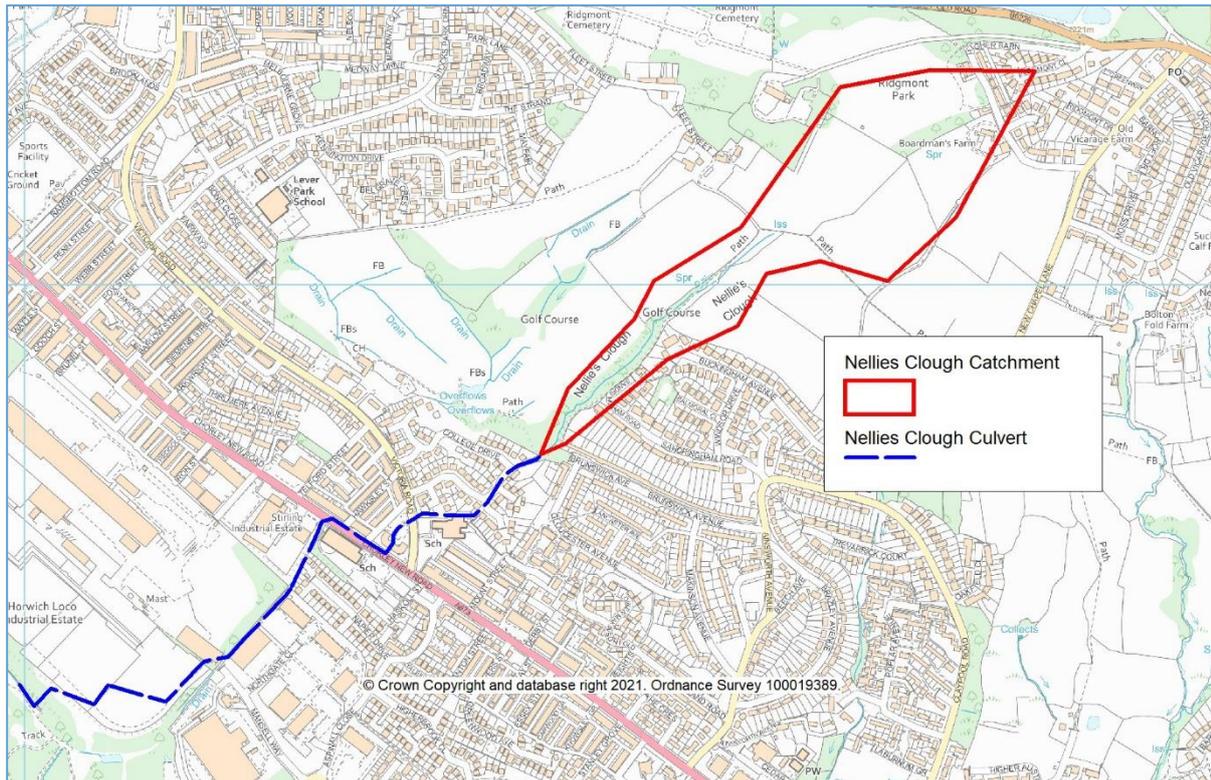
Figure 13: Map of the location of the Nellies Clough catchment, culvert inlet and route of the downstream culvert.

This catchment drains to a privately owned culvert inlet at the rear of College Drive. It is then carried in a culvert in a south-west direction passing under private property, when it reaches Chorley New Road it is routed along the road in a westerly direction until it reaches Chorley New Road Primary Academy where it changes course and runs in a south-west direction under the Horwich Loco Works Site where it discharges to a tributary of Pearl Brook. In the Horwich Loco works site it merges with the flow from the Horwich Golf Course eastern and western catchments.

It is estimated that the rate of run off of water for this catchment at the inlet to the culvert at College Drive during a 1 in 30 year storm is 290 l/s and for a 1 in 100 year storm 355 l/s.

An inspection of the watercourse upstream of College Drive in the days following the storm showed that the stream bed of the watercourse had been visibly eroded over a length of approximately 340 metres. The stream bed had been scoured down to clean rock and earth, the previous stream bed which would have comprised rocks, stones and earth will have been washed downstream by fast flowing water (Photographs showing the stream bed after the storm are included in appendix 4). In addition, several small landslides to the stream embankments along the valley were observed, these would have occurred during the event and released additional earthen material to be washed downstream.

The debris load flowing downstream will have quickly blinded the debris screen on the inlet to the culvert at College Drive resulting in the overland flow that was witnessed. It was this overland flow that caused flooding to properties on the eastern side of College Drive, to St Mary's RC Primary School, and Dale Street West. The following day significant quantities of material were dug out from in front of the debris screen and disposed of.

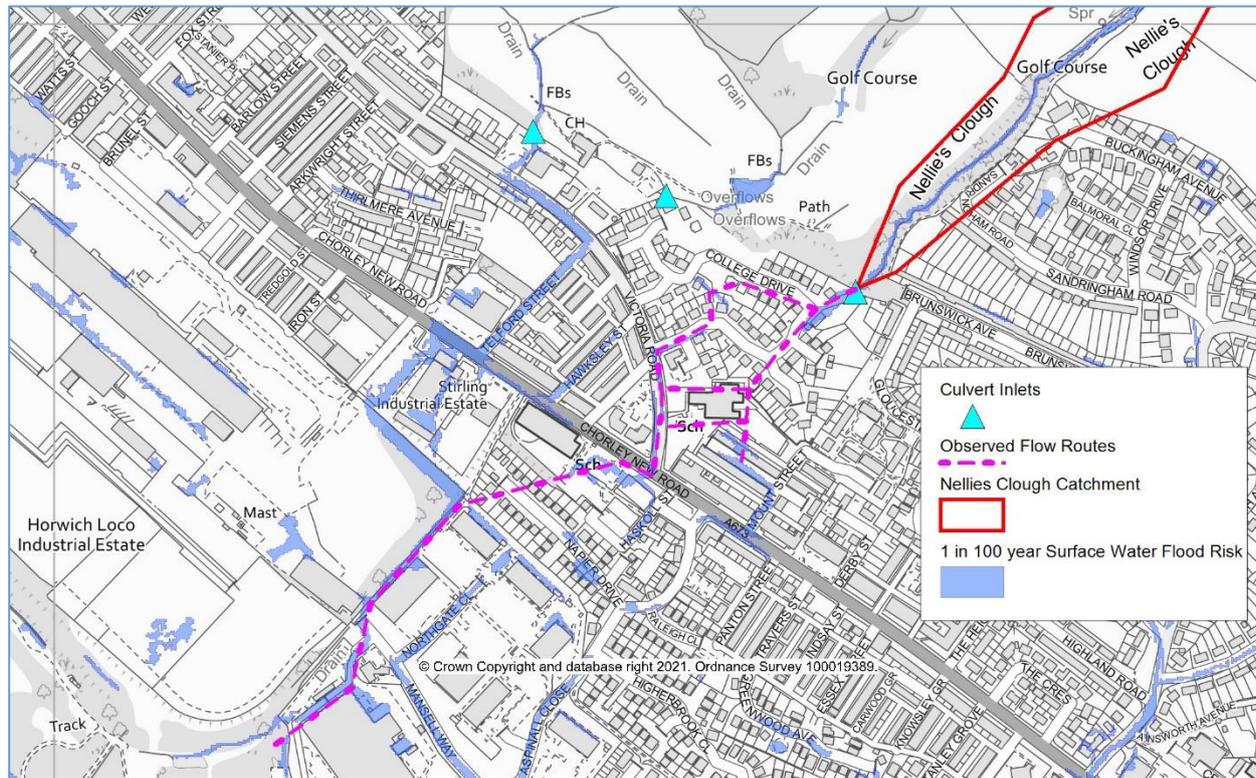
Figure 14: Map of the Nellies Cough catchment, the predicted surface water flood extent for a 1 in 100 year event and the observed overland flow route.

During the rainfall event significant water flows were observed flowing overland from the culvert inlet from Nellies Cough at the rear of College Drive, this resulted in internal property flooding on College Drive, St Marys RC Primary School on Victoria Road and on Dale Street West. Water has then continued across Chorley New Road across the Primary School site and then flowed south through the Middlebrook development where it contributed to further flooding of property.

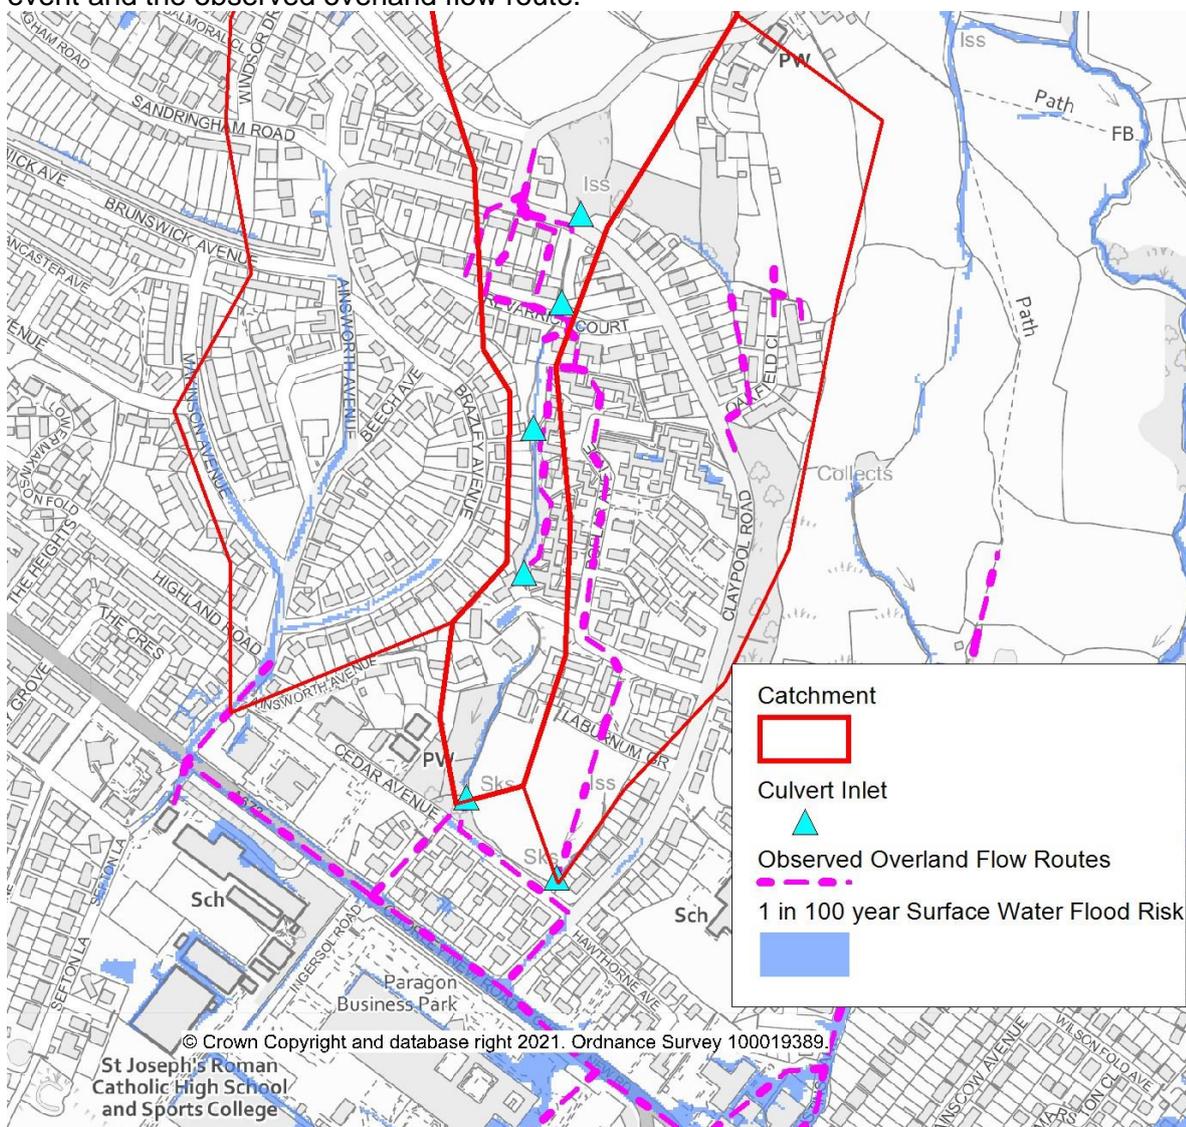
Figure 16: Map of the catchment, the predicted surface water flood extent for a 1 in 100 year event and the observed overland flow route.

Flooding occurred within the catchment as a result of a significant overland flow from land either side of New Chapel Lane this flow of water headed in a southerly direction from the top of Claypool Road through the urban area.

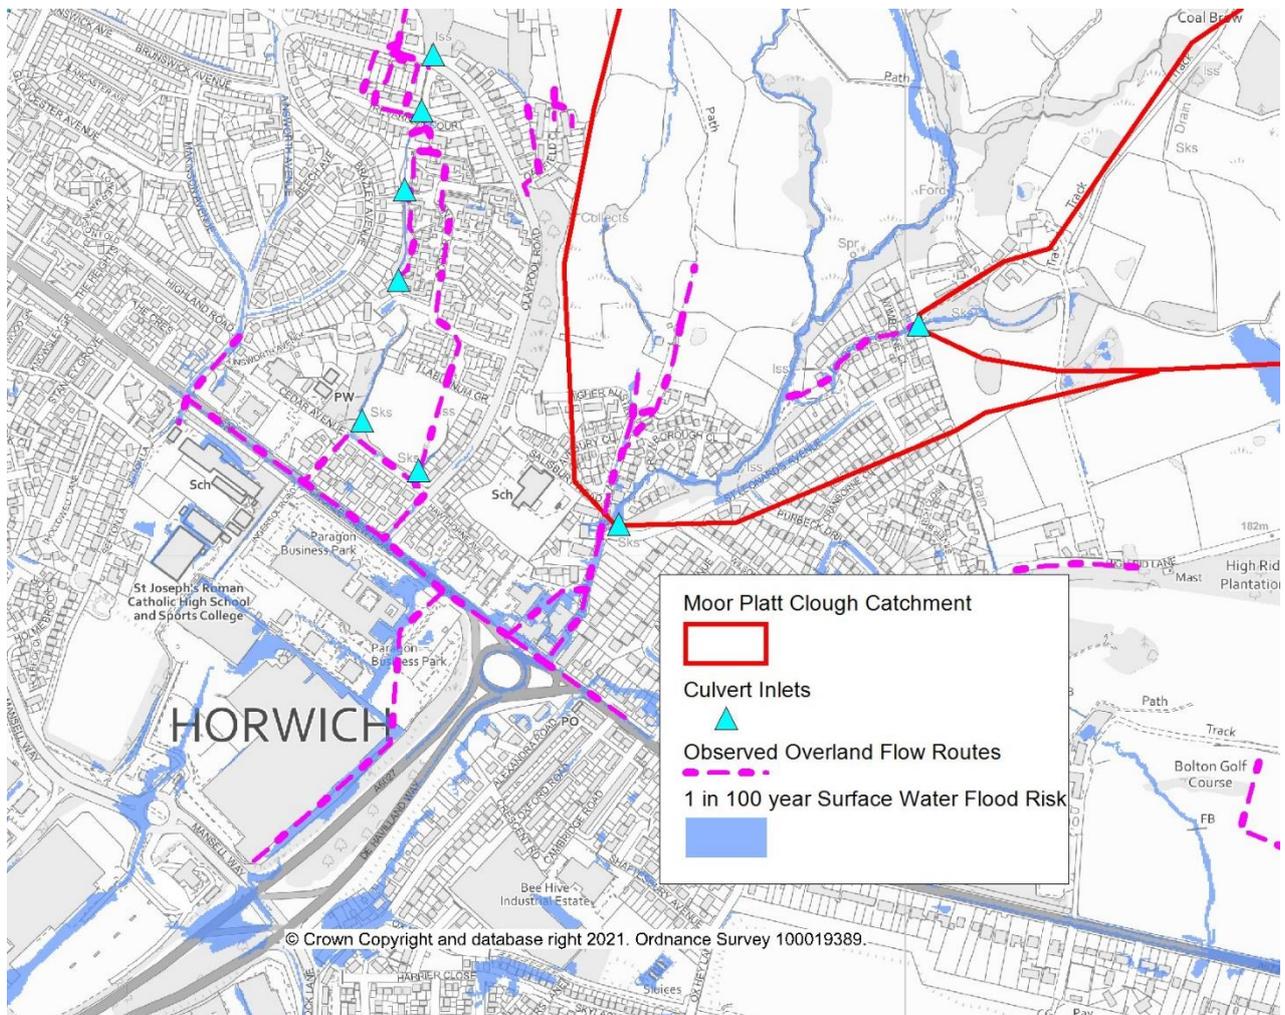
Figure 18: Map of the Moor Platt Cough catchment, the predicted surface water flood extent for a 1 in 100 year event and the observed overland flow route.

This catchment is the second largest of those impacted by the storm and observations indicate that this was the catchment that produced the greatest volume of flood water.

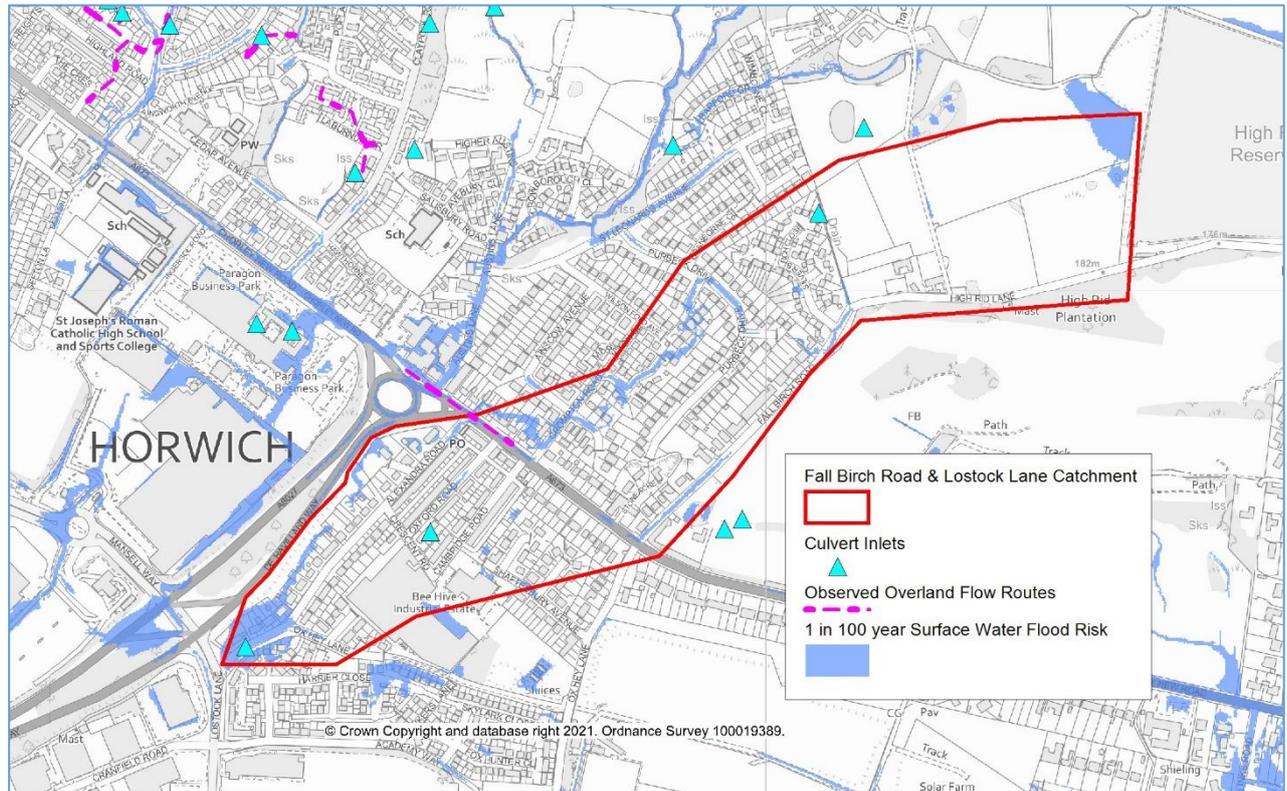
Figure 20: Map of the Fall Birch Road / Lostock Lane catchment, the predicted surface water flood extent for a 1 in 100 year event and the observed overland flow route.

At the upper reaches of the catchment overland flow from the fields to the west of High Rid Reservoir entered the developed area causing flooding to property and gardens.

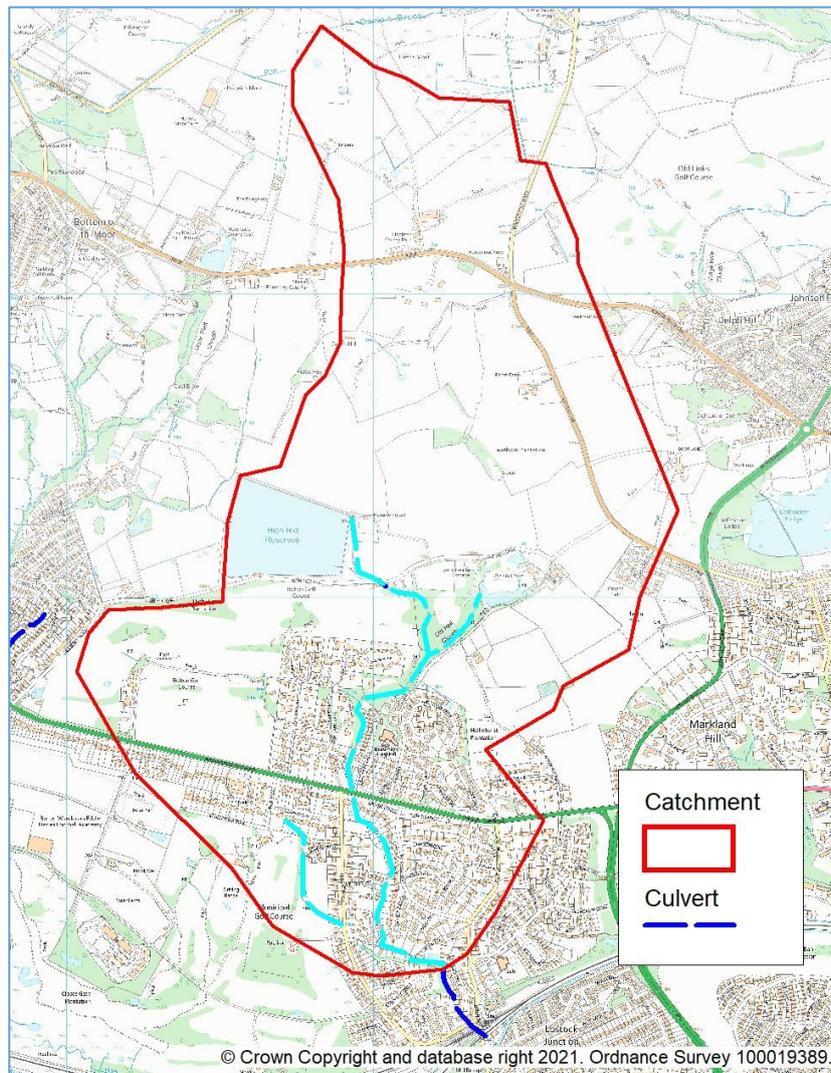
Figure 21: Map of the location of the Bessy Brook catchment, culvert inlet and route of the downstream culvert.

Flooding in this catchment occurred lower down the catchment at Sudbury Drive / Ashridge Close and was as a result of fluvial flooding from the Bessy Brook watercourse. The flooding at this location has occurred several times and is generally due either to a blockage of a debris screen at a culvert inlet or under capacity in a section of culvert. In this case, the indication is that the capacity of the culvert was overwhelmed on this occasion.

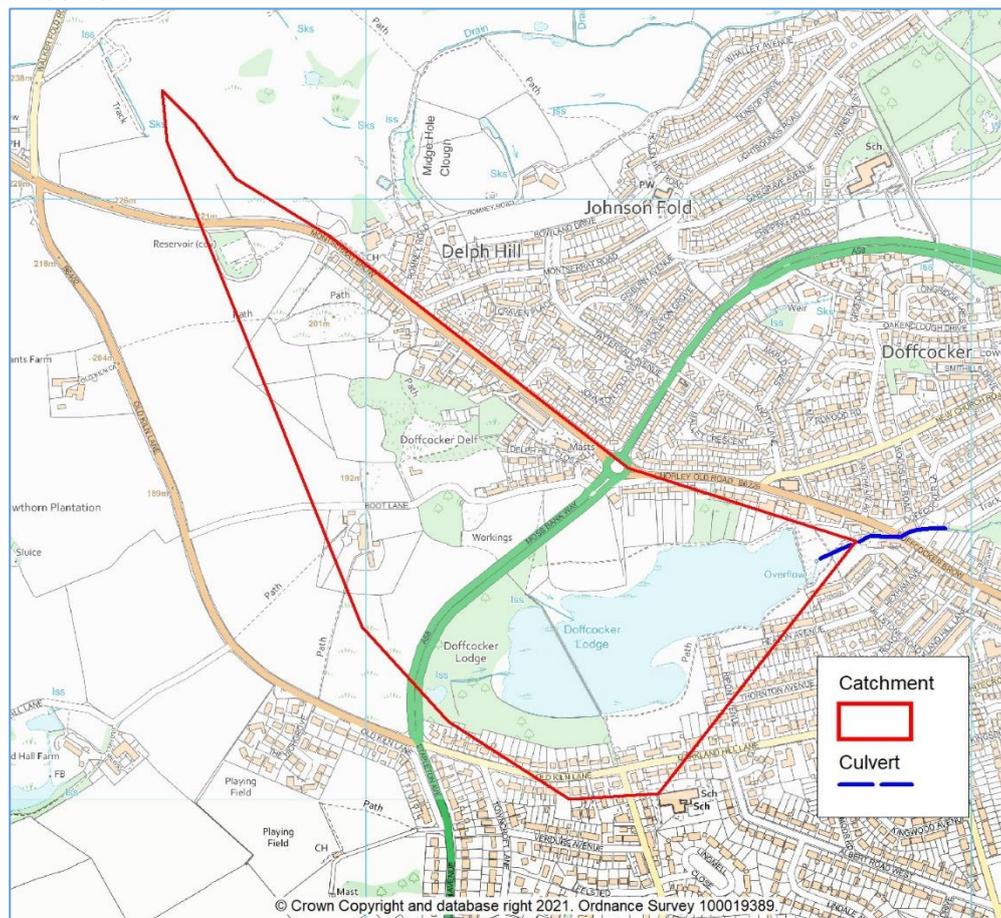
Figure 22: Map of the location of the Doffcocker Lodge catchment, culvert inlet and route of the downstream culvert.

The catchment shown outlined in red on the plan below is approximately 49 hectares, most of the catchment is not developed and contains mainly pastoral agricultural land. There is a reservoir called Doffcocker Lodge within the catchment. The lodge was historically used for the collection and storage of water to supply a mill, it is now used only as a nature reserve and for recreation.

Flooding occurred in the catchment as a result of outflow from Doffcocker Lodge overwhelming a culvert under Chorley Old Road.

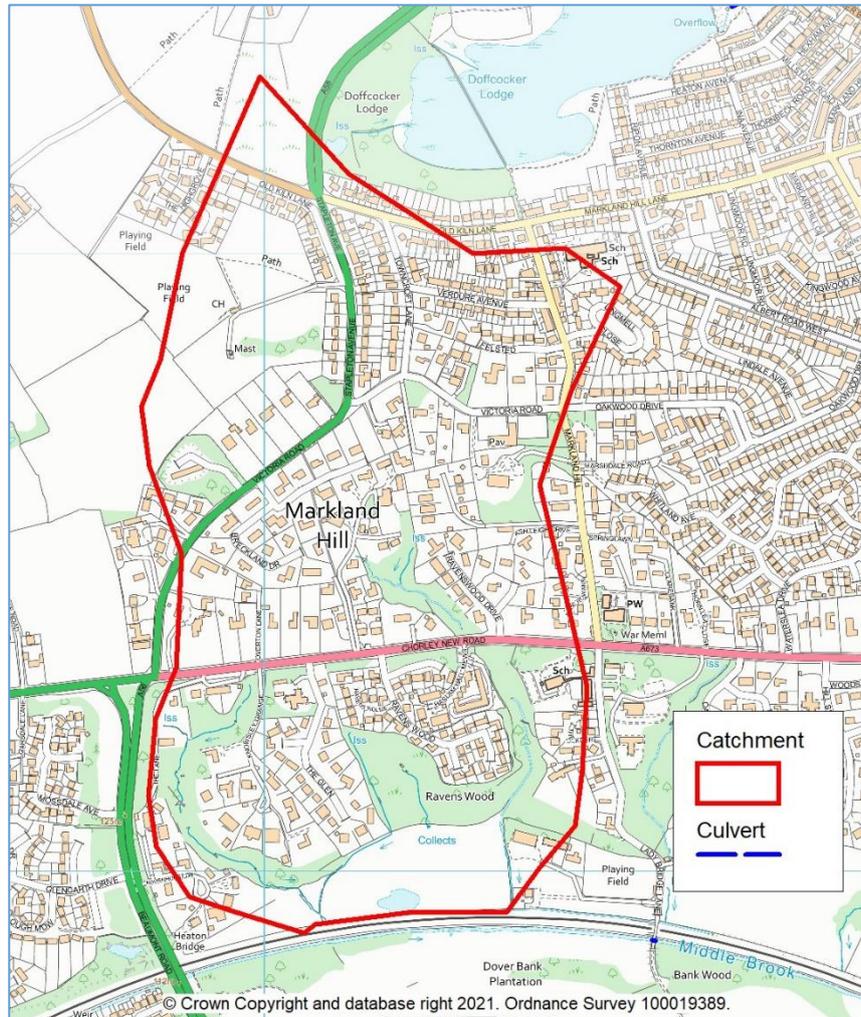
Figure 23: Map of the location of the Markland Hill catchment.

The catchment shown outlined in red on the plan below is approximately 76 hectares, most of the catchment is developed and drained via the sewer network.

Flooding occurred in the catchment as a result of overland surface water flow and some sewer surcharge.
